Before, During and After Photos

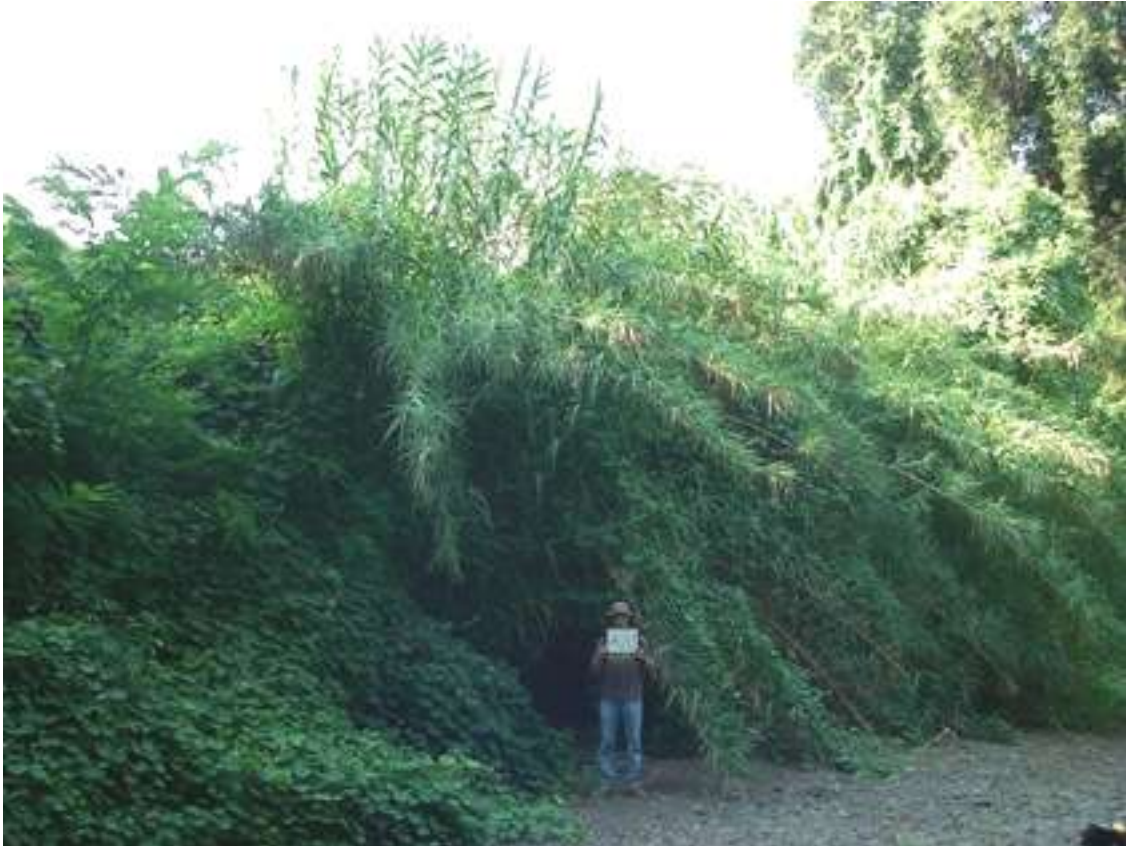
Before Treatment

Photo Date: 8/3/2006

Description: Large infestation in Lindo Channel, surrounded by extensive vegetation.

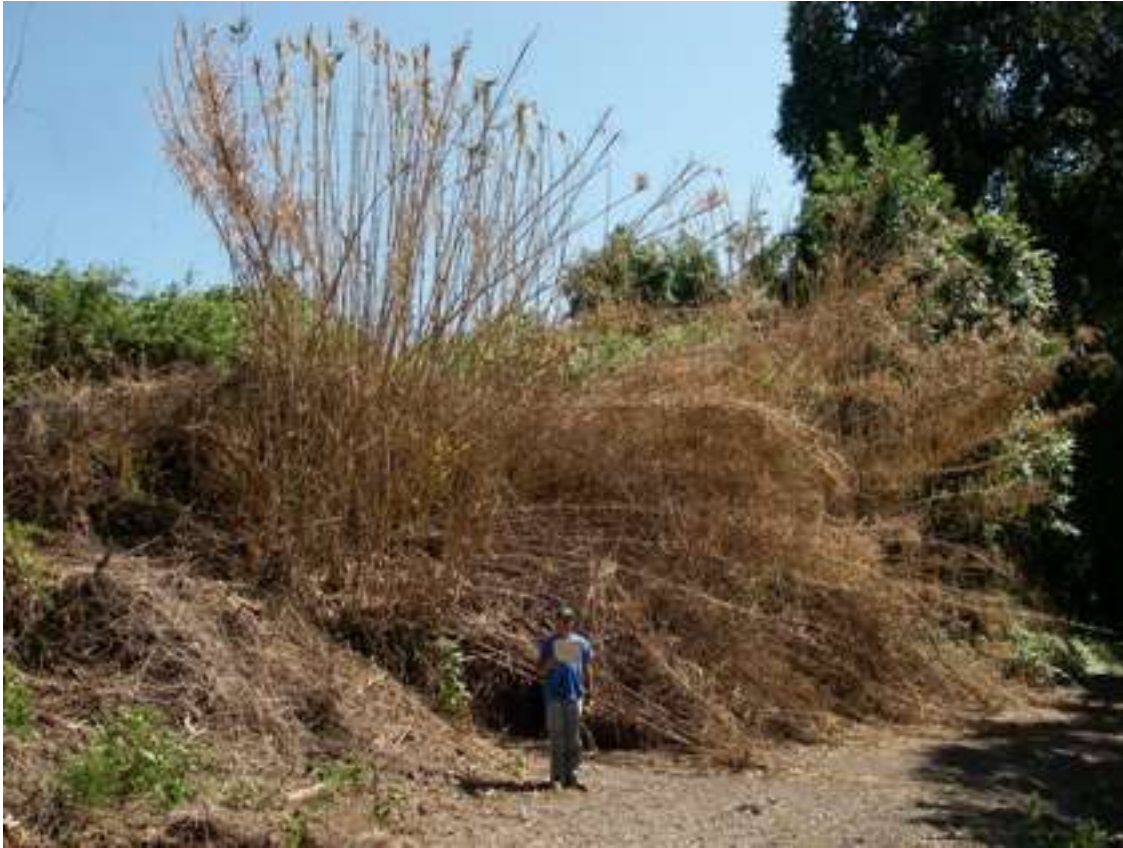
After First Treatment

Photo Date: 7/21/2007

Description: Treated in October 2006 using a foliar application of Glyphosate and Imazypr (2:1 ratio). Note that there is still green foliage on the tops of some of the canes.

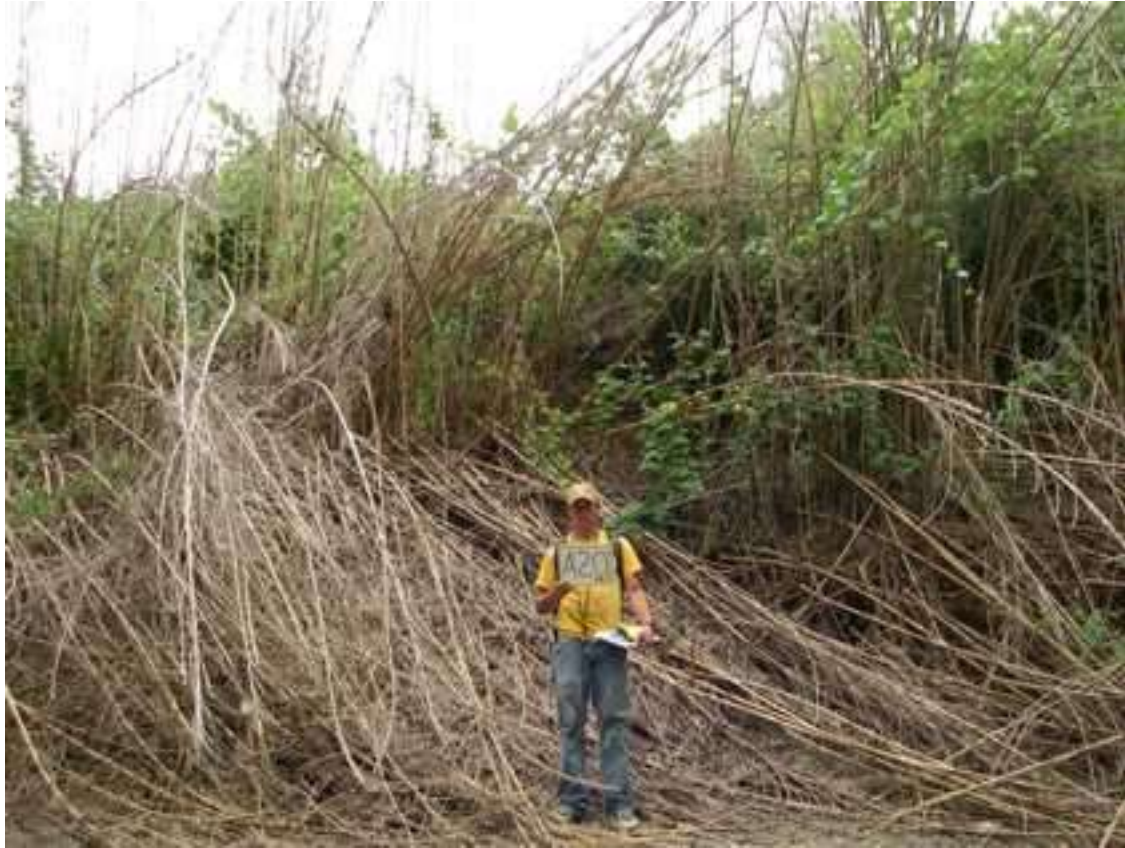
After Second Treatment

Photo Date: 5/26/08

Description: Re-treated in October 2007 using a foliar application of Glyphosate and Imazypr (2:1 ratio). Note that most of the infestation has begun to decay and disappear, with surrounding vegetation taking over the site.
